Forest Service
Pacific Northwest Region
R6-NR-WFW-05-05
Portland, OR
July 2005

Ridge Top to Valley Bottom

RESTORING WHOLE WATERSHEDS

WHOLE WATERSHED RESTORATION

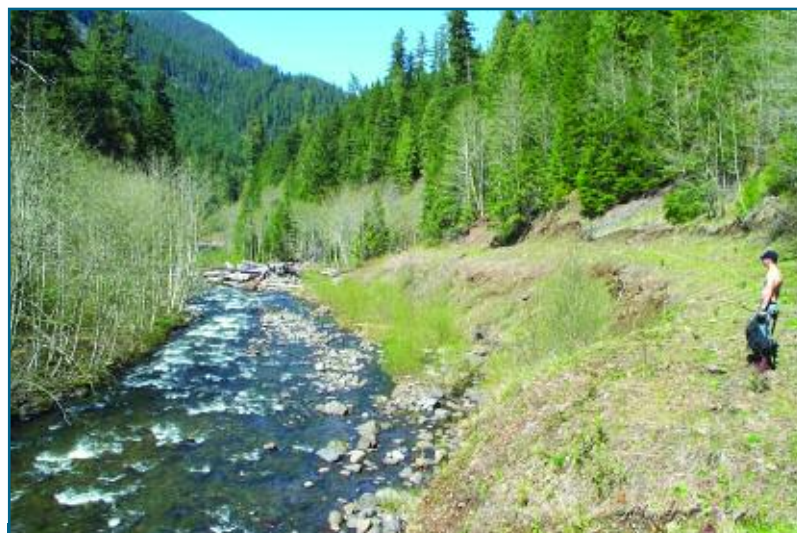
Watershed restoration uses a variety of techniques to improve fish habitat in streams. In the Fish Creek watershed, a road adjacent to the stream was removed which reduced sediment entering the stream and allowed re-establishment of riparian vegetation and important channel processes.

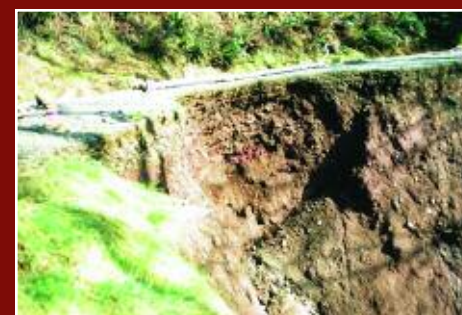
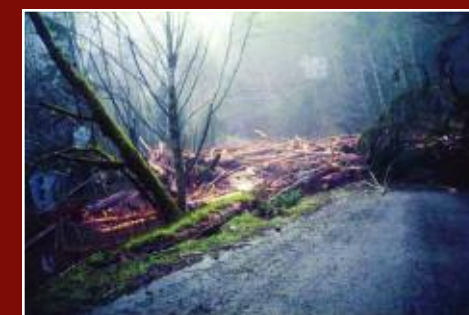
Prior to restoration and road decommissioning, there were many road-related landslides in the watershed (left). These slides often move large volumes of sediment and wood which affect stream channels and fish habitat (right).

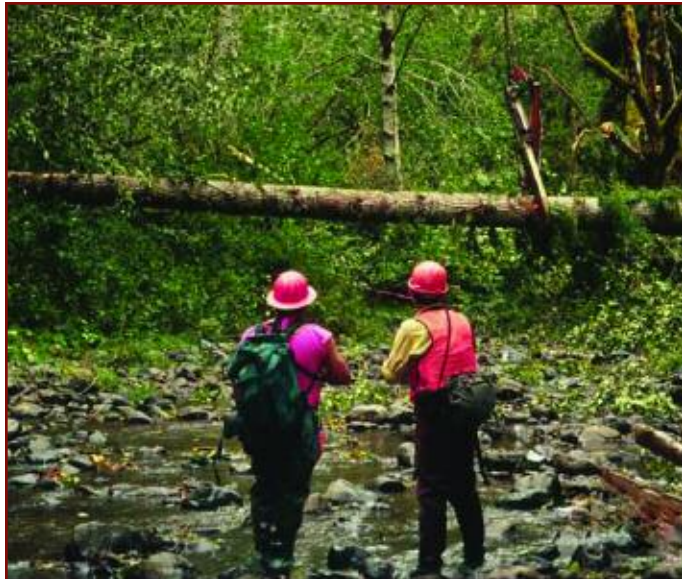
A helicopter was used to bring in more than 240 large trees to sections of stream lacking in wood. Large trees, typical of a mature riparian area, are more stable and provide better habitat for juvenile fish during winter high flows.

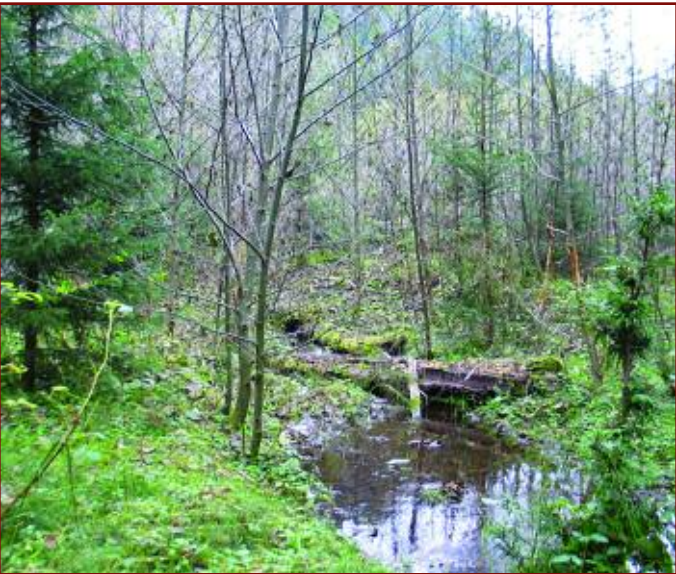
The photo above shows an area where a road and a gravel pit located in the floodplain were decommissioned. The road was de-compacted, planted with native riparian vegetation, and a portion of a tributary of Tenmile Creek was redirected back into the historic channel. The final result was restoration of several hundred feet of important over-wintering habitat and winter flood refugia for fish and other aquatic species.

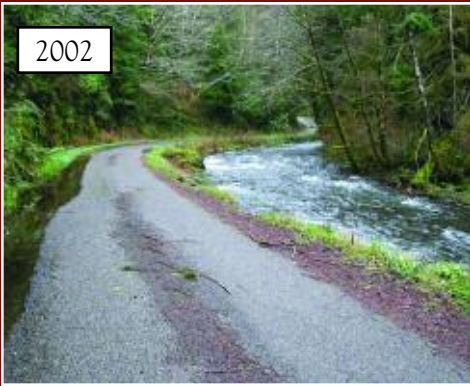
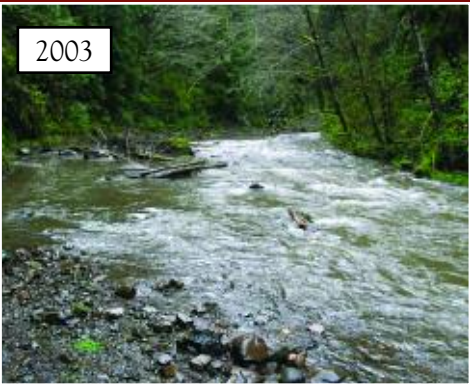
The photos show a road decommissioning project in the Cummins-Tenmile Creek watershed. The access planning team concluded this section of road was no longer needed. Road removal allows the stream full access to the floodplain during winter high flows. With greater access to floodplain habitat and backwaters, the stream channel now retains large wood and other roughness elements important for fish habitat.

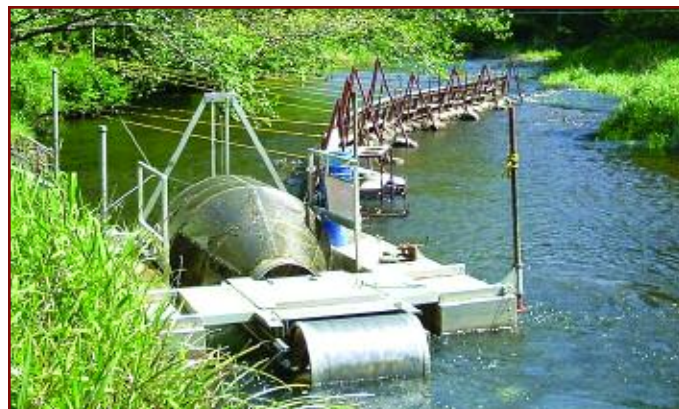
Smolt traps are used to monitor fish population response to restoration treatments.

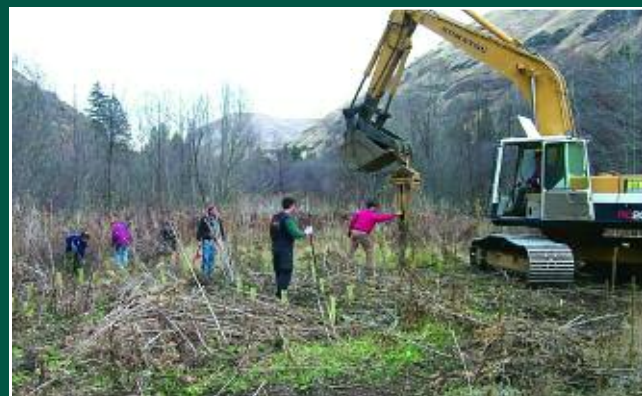
Volunteers, students, and Salmon Corps assisted with riparian plantings. Several pieces of innovative machinery were developed to aid in restoration. A small tracked excavator with a “stinger” attachment (shown in photo) was used to “drill” plantings further down into the water table.

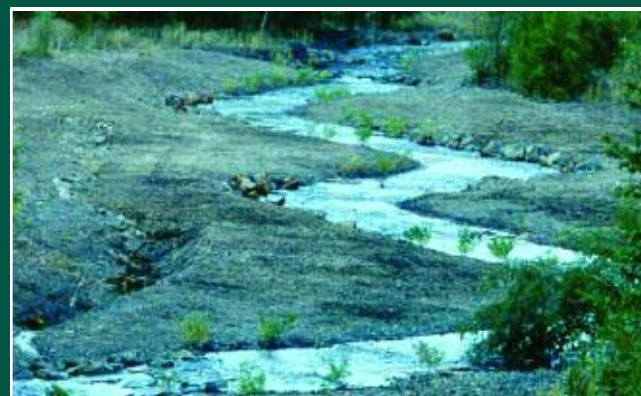
Channelized, linear stream segments were “re-meandered”, to emulate natural stream patterns, stabilize banks, and improve aquatic habitat. A variety of native trees and shrubs were planted: four varieties of willow, cottonwood, red osier dogwood, blue elderberry, ponderosa pine, Douglas fir and quaking aspen.

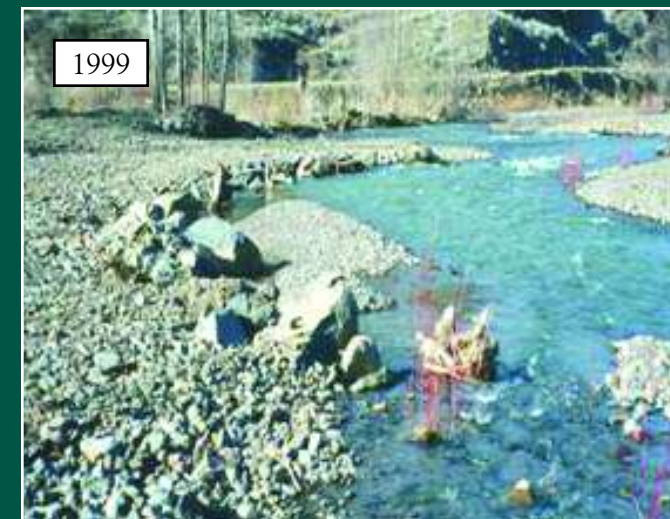
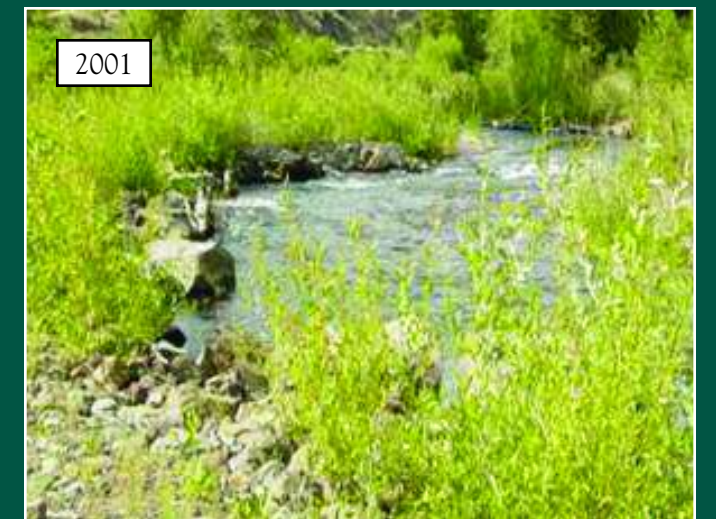
The Koch Project “re-meandered” an important section of Asotin Creek. The project increased the length of stream channel by more than 40% and the amount of pool habitat by more than 33%.

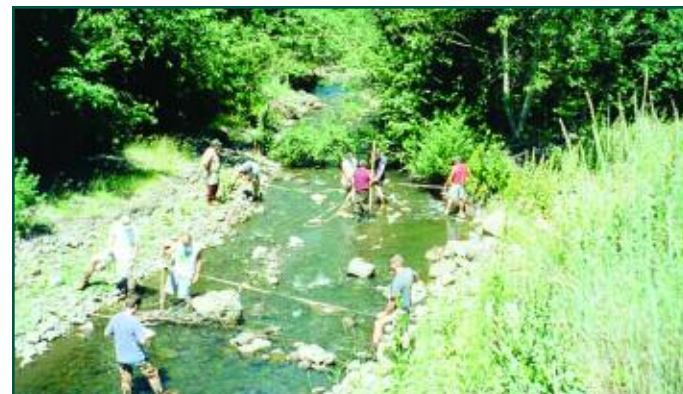
Monitoring has included measuring stream width, pool frequency and depth, and average stream depth.

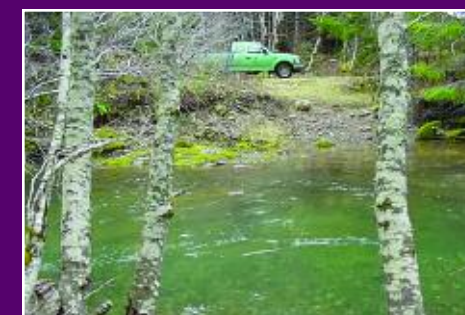
Prior to restoration, the streambed of Little Rock Creek was dominated by bedrock which provided poor spawning and rearing habitat for fish (left). Roads in the watershed impinged on the floodplain, contributing to sediment and erosion (right).

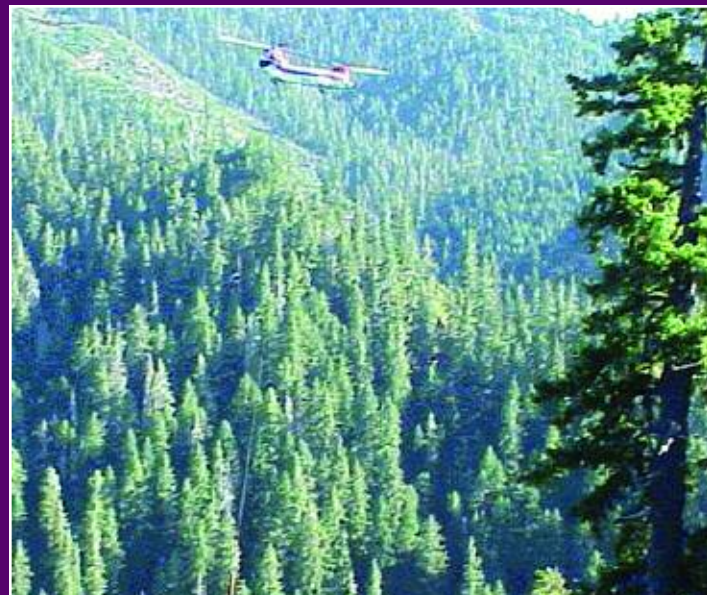
A large, heavy-lift helicopter was used to bring 550 logs into eight miles of Little Rock Creek and three of its tributaries. This was done to restore the large wood habitat that was lost as a result of the 1964 floods and subsequent stream cleanout in the 1960s and 1970s. The logs, all downed by storms in 1996, were gathered from nearby roads. Large wood is important to stream health and fish habitat development, providing hiding cover, physical structure to form pools and trap spawning gravels/sediment, and a steady source of nutrients.

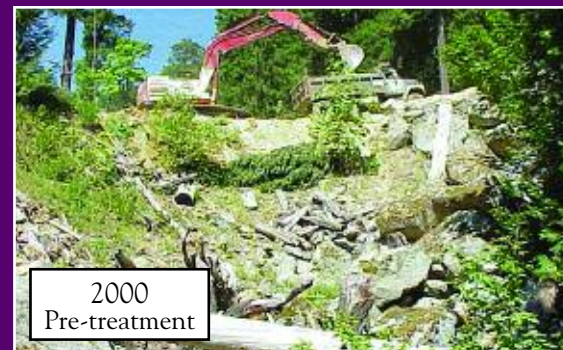
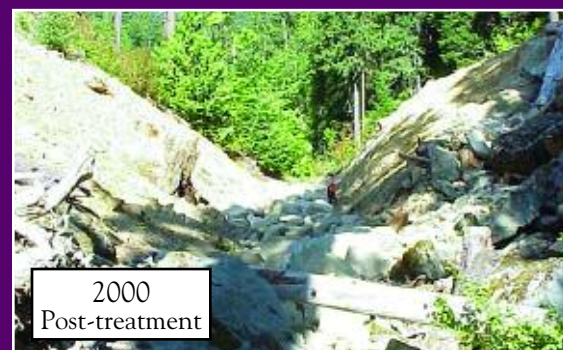
Many road-stream crossings in this watershed altered sediment and debris movement in stream channels and blocked fish passage (left). Restoration projects have returned channels to a natural grade and condition. In many instances, road decommissioning removed a stream crossing completely (right).

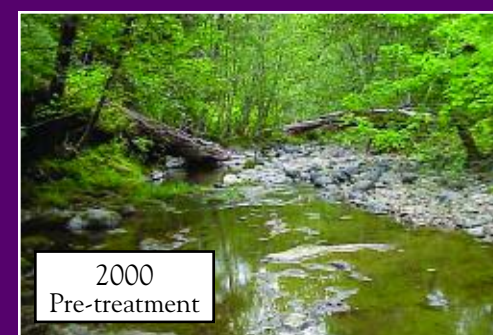
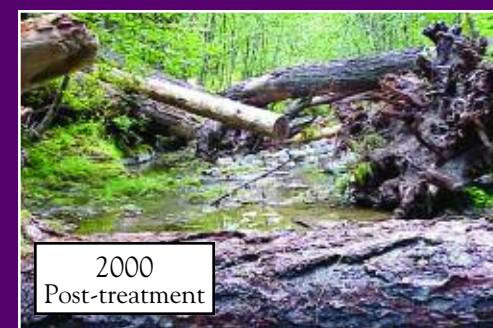
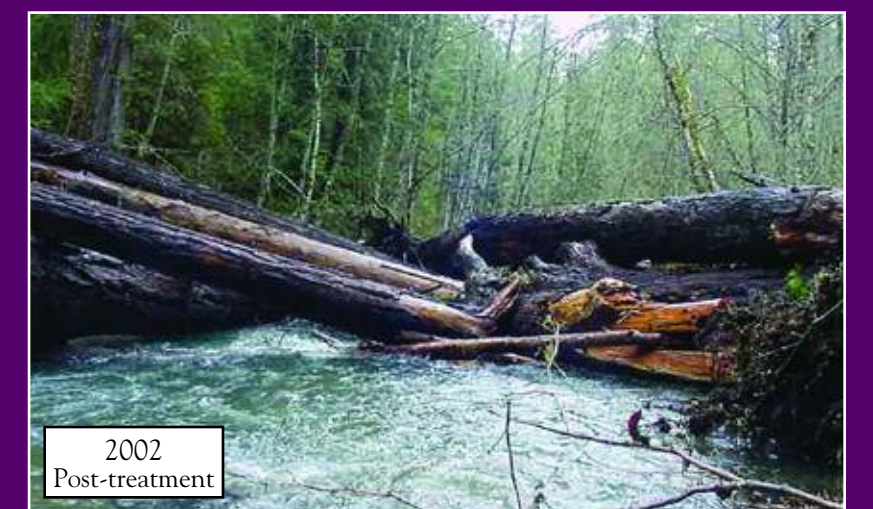
This sequence of photographs shows the progression of a representative stream channel restoration site in the Little Rock Creek Watershed. Large wood was introduced in 2000 to enhance fish habitat. Two years after project implementation, surveyors found numerous juvenile steelhead utilizing pools and backwater habitat created by the large wood jam.

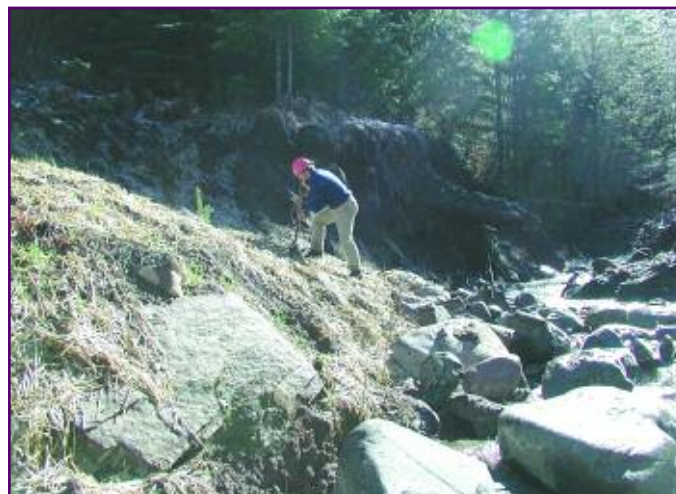
Volunteers worked with Forest Service employees to plant willow, Western red cedar, and Douglas-fir trees along riparian areas where roads were decommissioned and stream crossings were removed.

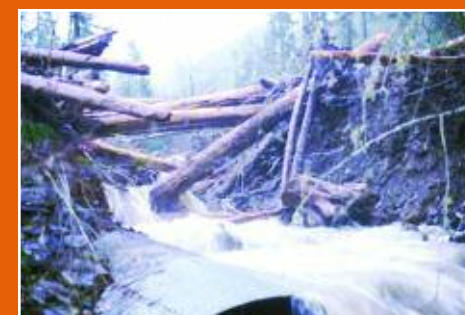
Before restoration wood added to streams by landslides was often trapped behind culverts— causing major debris jams and forcing the stream to create new channels (left). Floods and landslides triggered road washouts and damage along Fish Creek and its tributaries (right). All Fish Creek photos by USFS.

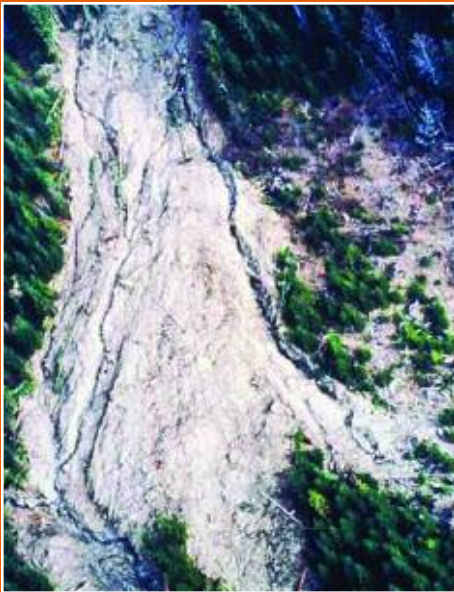
Tree plantations (harvested areas less than 20 years old) had ten times the landslide rate than that of old growth stands. Many landslides were replanted, and adjacent plantations were thinned to accelerate tree growth.

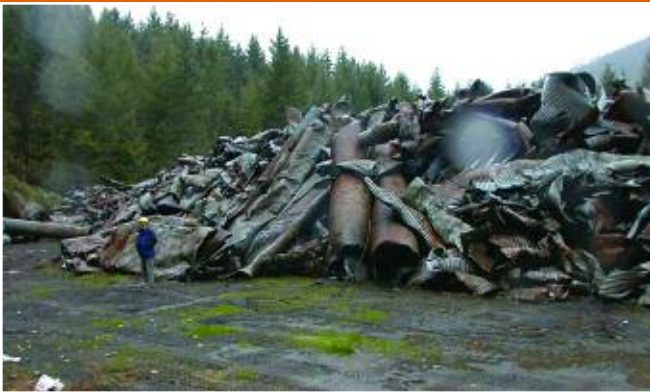
An estimated one million pounds of culverts were removed from Fish Creek watershed.

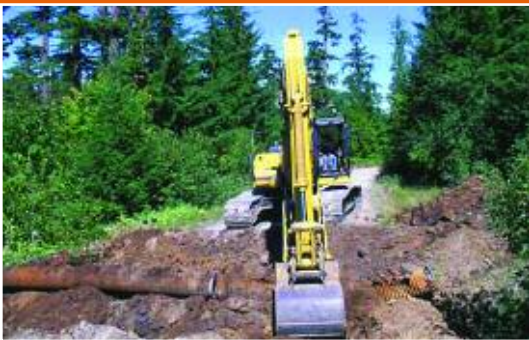
A key step in the restoration of the Fish Creek watershed was road decommissioning. By removing culverts and restoring the natural flow of water and stream habitat components, such as large wood, streams are healthier and provide better habitat for fish.

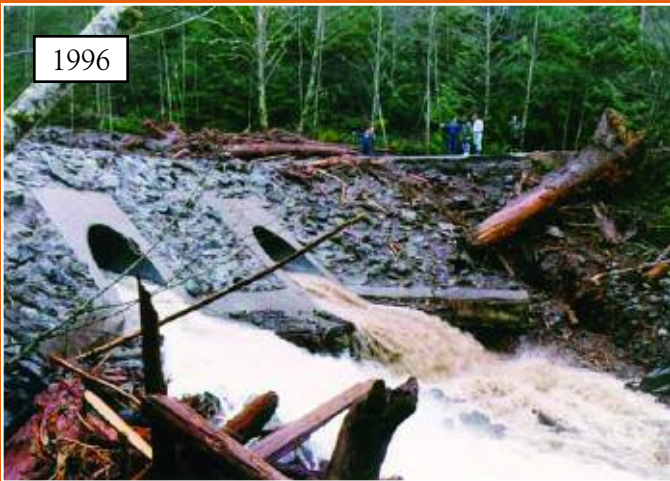
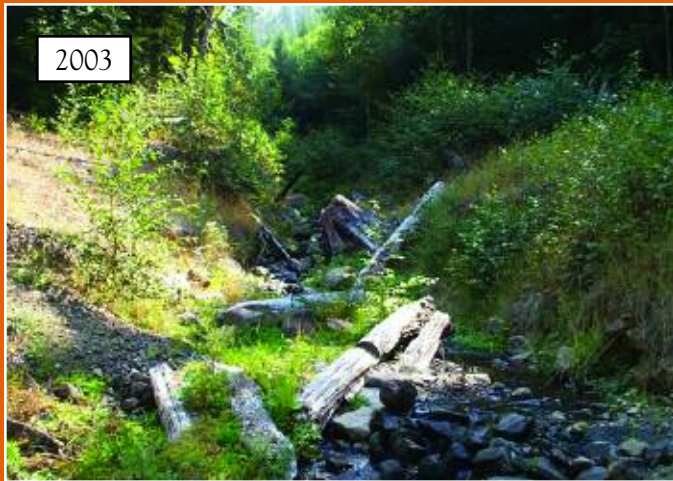
The two photos above (before and after) show typical results of Fish Creek road-stream crossing restoration. The road crossing on Third Creek was obliterated, the culverts were removed, and the stream bank was returned to its natural grade. Large wood deposited in the 1996 flood was moved back into the stream channel to enhance fish habitat. Following reconstruction of the stream channel, erosion control materials were applied. Shrubs and trees, such as the alder, sprouted naturally.

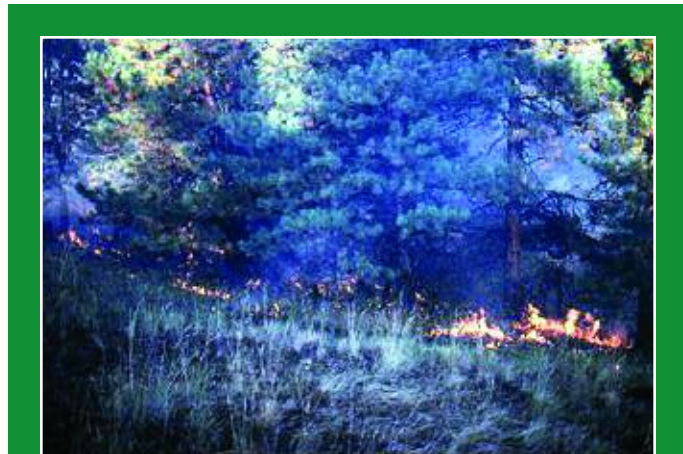
Prescribed burns were important in reducing invasive, non-native plant species and the build up of fuels. The result is an ecosystem with more native species and a reduced risk of catastrophe from wildfire.

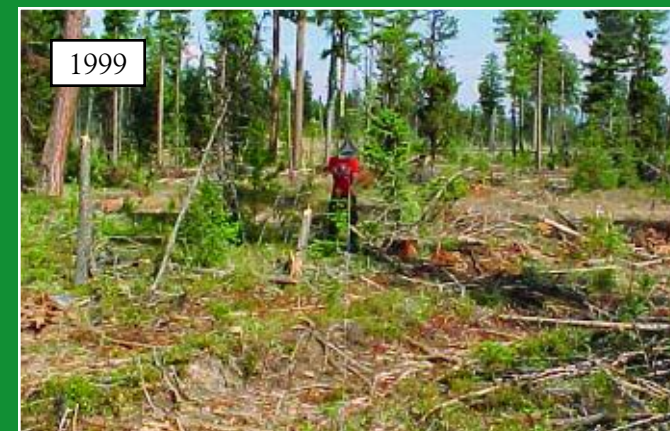
Fuels were reduced in the Meadow Creek watershed using a combination of thinning and prescribed fires. These photos show an area before and after treatment.

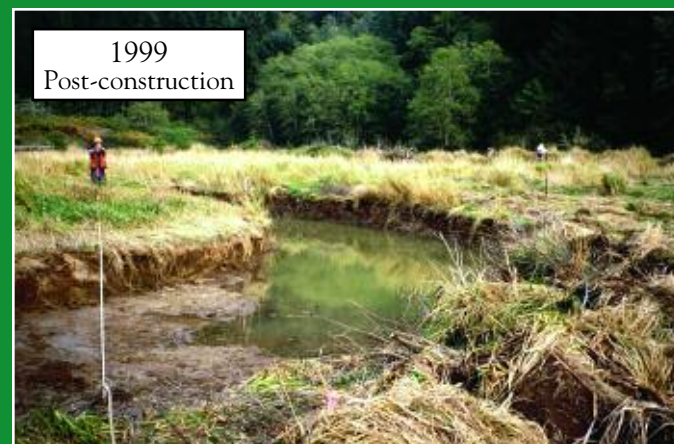
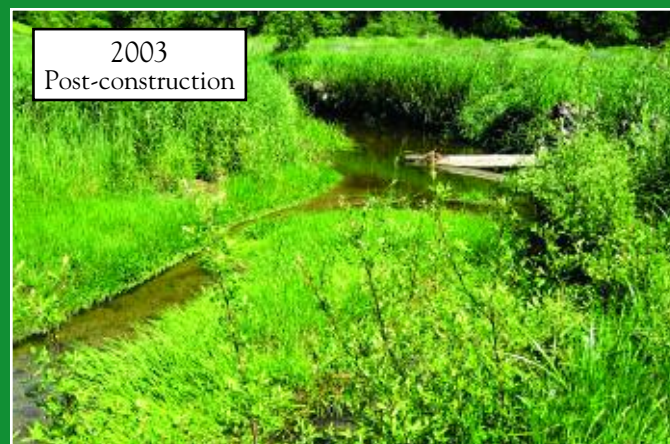
After the new meandering channel was constructed in 1999 (left), pieces of large wood were added to the stream to enhance fish habitat. As the riparian vegetation matures, it will cool the stream by providing shade.

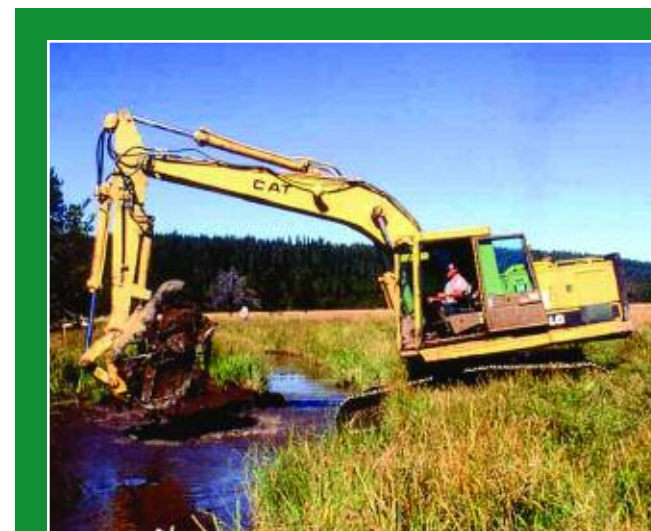
Excavators were used in restoring the hydrology of the Big Marsh Creek ecosystem. Removal of human-built ditches and returning the stream to its natural channel enhances habitat for many species including redband trout, Oregon spotted frogs, Sandhill cranes, and yellow rails.

Natural movement of water through the marsh was restored by diverting water from the existing ditches back into Big Marsh Creek and its wetlands. A series of small “check dams” were constructed in the existing ditches to decrease water flow, allowing sediment to settle and water to infiltrate back into the marsh. This recaptured 3 miles of stream and returned 90% of the water to its historic channel.

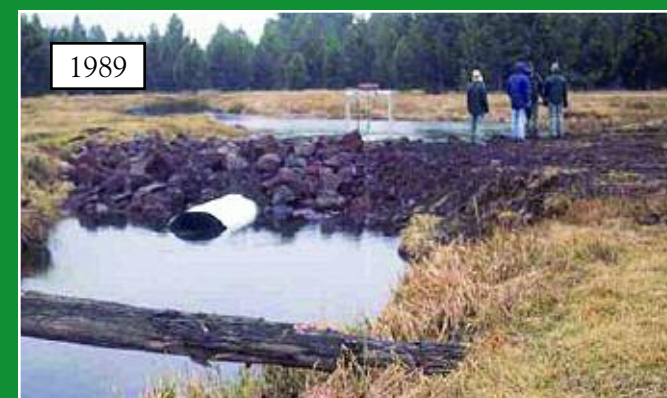
A “head gate”, controlling the rate of water flow, was constructed in 1989 to allow water to move back into Big Marsh Creek (left). It was removed in 1997, and historic stream channels that had filled in were also excavated (right).
